Paul Pouvillon's Astronomical Clock
A Brief History and Description of the Clock's Restoration
By Mark Frank

A Brief History and a Description of the Clock's Restoration

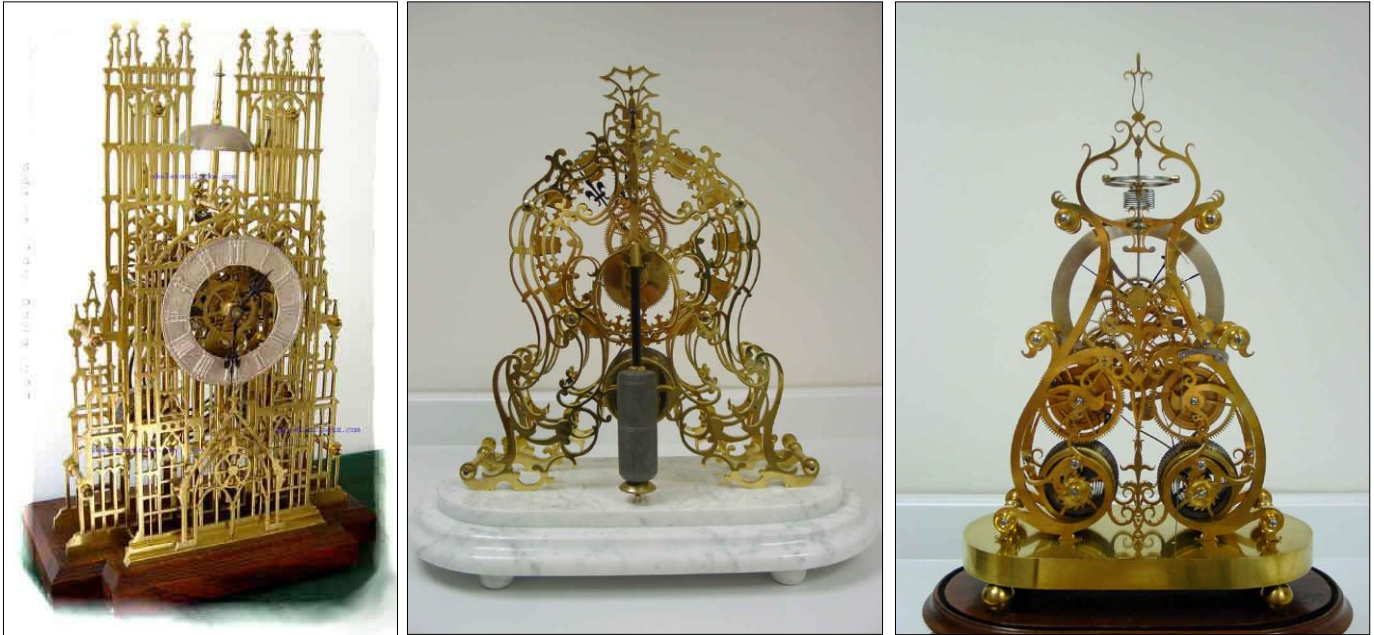
Figures 8a-c. Various styles of skeleton clock frames, all using conventional plate and spacer design to secure the wheel works.

In the vast majority of clocks, the movement is clothed in a decorative exterior case of wood, stone, metal, porcelain or some combination of these. Skeleton clocks have an exterior case made of glass or sometimes plastic and are designed to let the observer view the clock movement; it is the movement frame that takes center stage. These can take the form of allegorical architectural designs based on famous churches and other public buildings or complex and elegant curvilinear designs like those of Evans or Condliff, (Figures 8a-c). This makes sense since in most clocks there are only a limited number of components that exist between the frames. Even in the most complicated conventional three train, quarter striking clocks one would find only between twelve to sixteen wheels and associated strike control mechanisms. So the designs of most skeleton clocks focus on the frames. Both conventional and skeleton clocks generally share the same type of frame construction. Plate and spacer construction has two solid plates held parallel and secured to each other by a series of pillars and in between these plates the wheels as well as the rest of the mechanism is supported. In skeleton clocks the nomenclature of the plate is changed to frame when that plate has been fretted out or skeletonized but both still perform the same function.

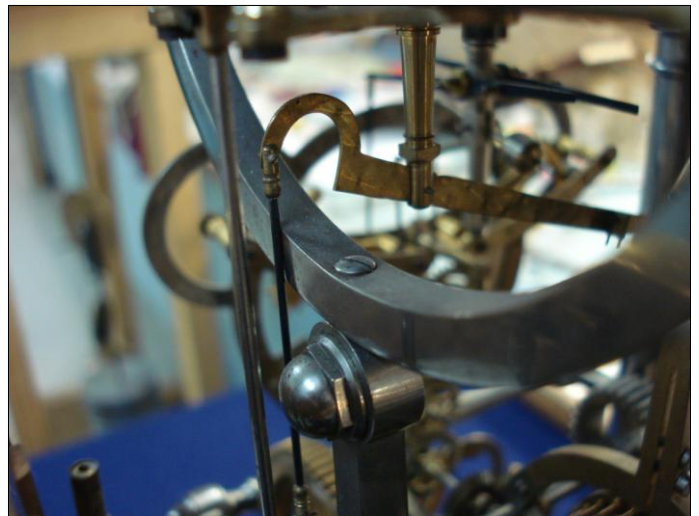
Figures 11a-f, continued.

There are many parts that have a 'quirky' look to them – long rods connecting to bevel wheels that are not always at right angles, (Figures 11a-g). Wheels, cams and levers are at different angles to each other as well as the viewer. This is all very different from the orderly way components must be arranged between two parallel positioned plates, which is the conventional plate and spacer design. Most of the clock was made over a ten year period, but other changes and additions and in one case an added component from another clock continued for an additional 20 years. During this time Pouvillon's skill and style of fabrication evolved and this is reflected throughout the clock's structure, further reinforcing its anachronistic quality.

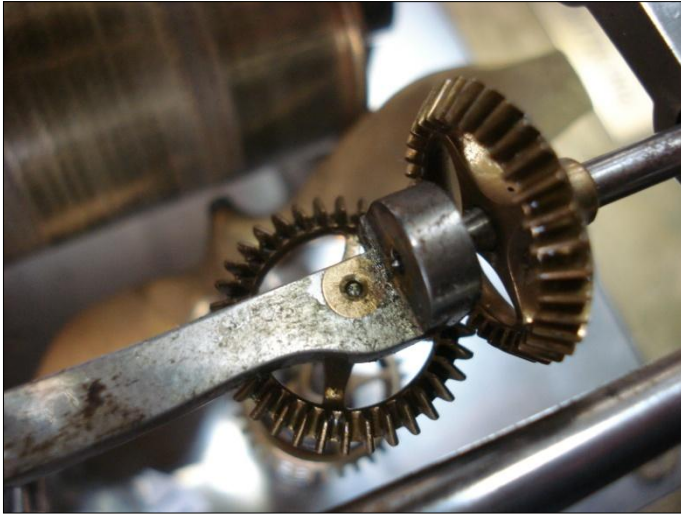
Figure 5. Fly fan potence showing later alterations

Figure 5 shows a potence with a wheel bush supporting the bevel drive to the strike fly. If one looks carefully it is clear that the upper side of the part which now is cut into the bush was originally flared in the same manner as the opposite side which meets flush with potence foot. Next we see the same part showing where the flair has been cut away, impinging on the previously installed bush, in order to provide sufficient clearance for the Easter calculator. (Figure 6).

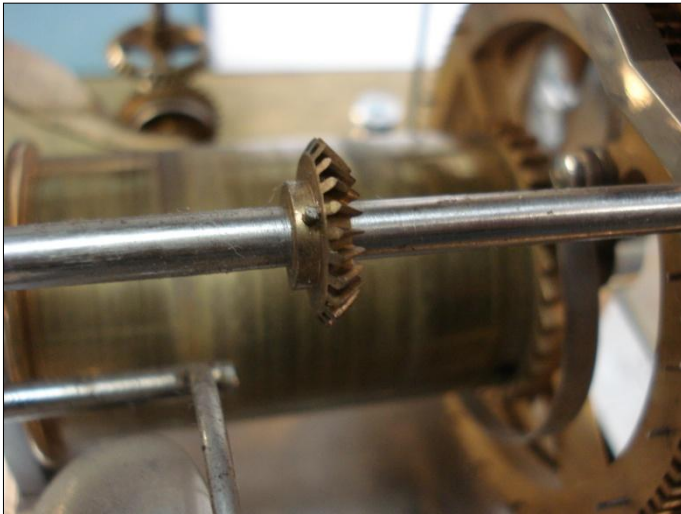
Figure 9. Later added bevel without mounting provision

All of the drives to the complications are mostly in the form of bevel wheels and are attached to the phase one arbors in what appears to be an ad hoc fashion. There are no provisions made for correct fitting of these later bevels on the tapered arbors, (Figure 9). In the phase one clock, all wheels had proper parallel mounting points on the otherwise tapered profile of the arbor, (Figure 10). None of these conditions would have been present with a clockmaker of Pouvillon's talent if the clock was pre-planned with the bevel drives for the complications. The fact that the phase one clock stands as a beautiful example in its own right completely stripped of all complications stands as testament to this, (Figures 12-14, next page).

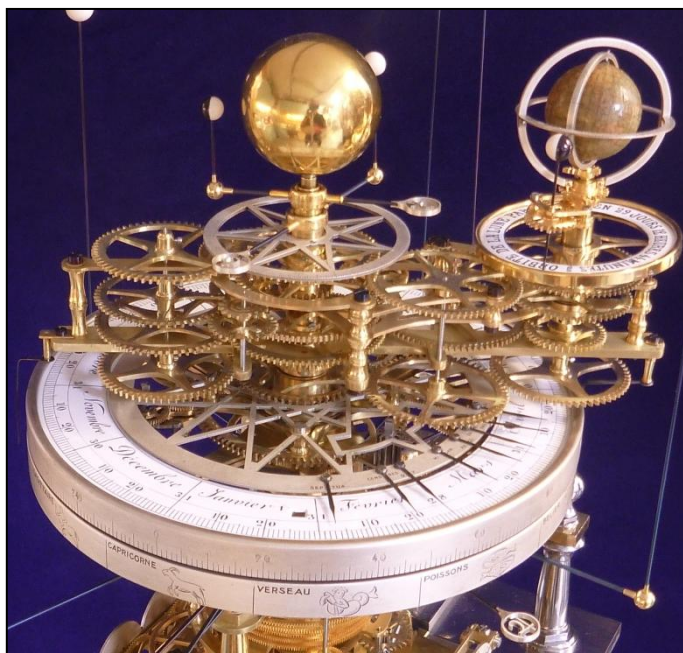
Figure 15. Pouvillon's tellurian

Phase two is just prior to 1930 and is the birth of the astronomical clock beginning with the addition of a tellurian Pouvillon acquired from another clock (not to be confused with the orrery controlling the outer planets which was by his own hand). That orrery mechanism is *below* the superstructure holding the tellurian and I believe this to be the first of his complications as many power feeds to other components located on the sides of the movement originate from this system. The tellurian is the only component that was not entirely made by Pouvillon and yet even here he remade the rotating frame components, making them more decorative than they were originally, (Figure 15). It is also the only complication that employs enamel dials. Figure 16 shows an identical tellurian in all respects, especially the enamel dials, but with a plainer rotating frame containing the same wheel works. This example appears on a movement signed by Antide Janvier. I have documented four other tellurians all made by the same hand as the one Pouvillon used. These have appeared on clocks made by Ferdinand Berthoud, Baltazar Pere, Giteau, as well as Janvier.¹⁰ It appears there was an independent fabricator of this device who was subcontracted by these important clock makers for its inclusion into their work. On this clock the two silver bands surrounding the enamel dial, center star grill and upper star grill are Pouvillon's additions and will be examined later in greater detail.

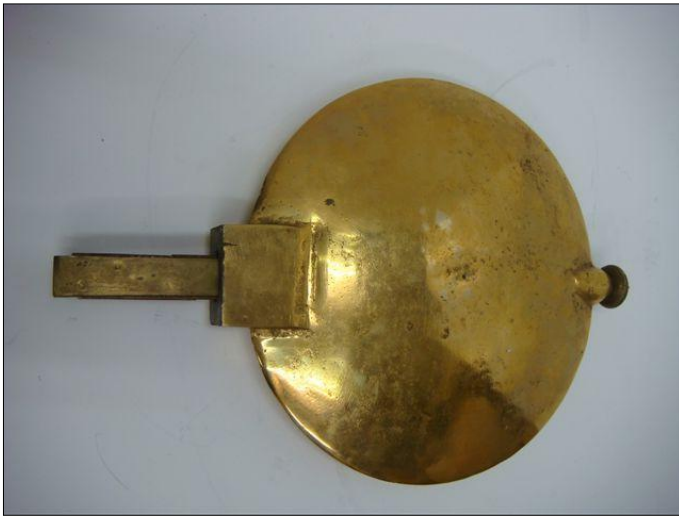
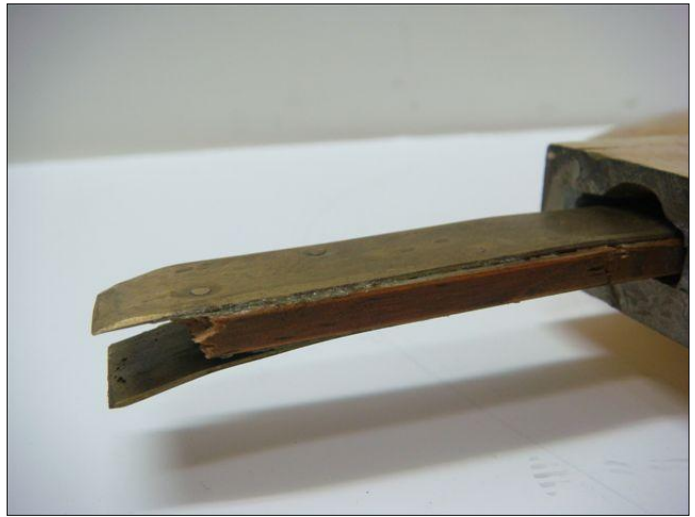
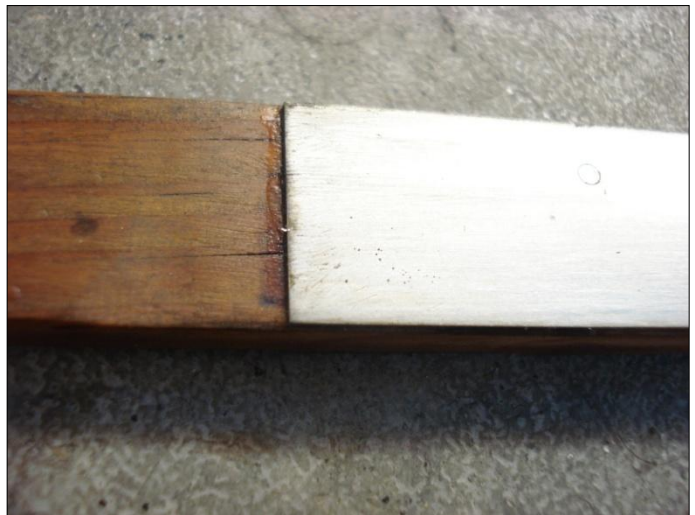
Figures. 1-4. Repairs made to the broken pendulum stick

1. Repair broken pendulum stick. The clock as received was not running. This may have been resolved by a conventional repair and cleaning of the existing movement. We found nothing actually broken or missing in the time or strike train except for the thin, wooden pendulum stick which was broken in one place. There was a previous repair to this stick in another area and it should be noted that the gilded pendulum bob, Figure 1, is very heavy in comparison to the stick at over 15 lb (7 kg), thus increasing the odds of such damage. We affected a repair using a metal brace riveted to the front and rear side of the flat rod in the same manner as the old repair, (Figures 1-4).

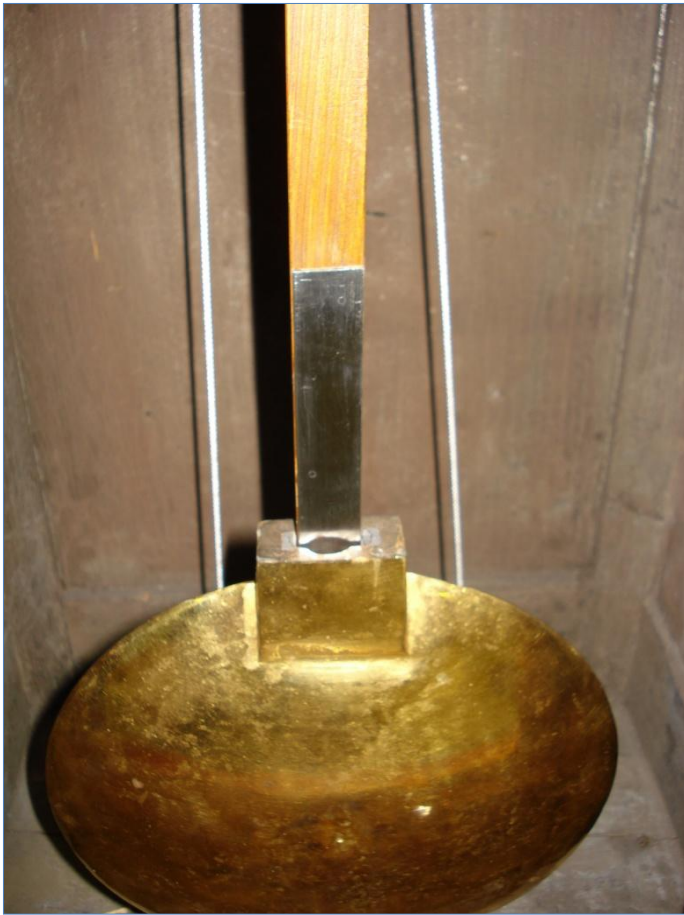
Figure 5. Completed repair; pendulum mounted in place

The completed pendulum repair is shown in Figure 5, next page.

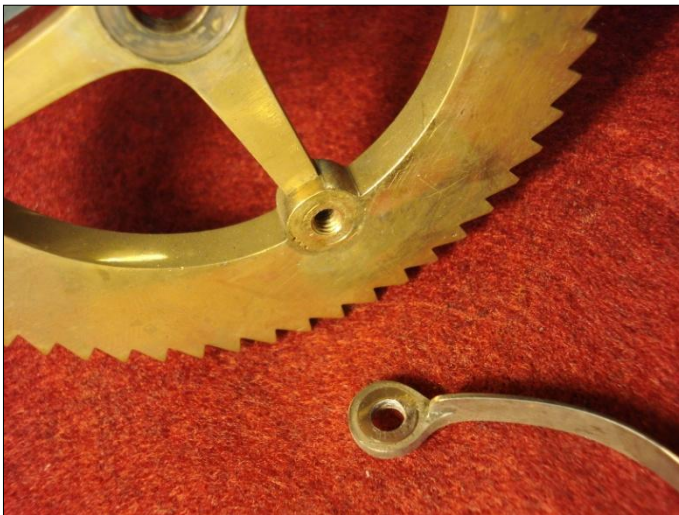
Figure 10. Unsecured time train click spring.

3. Secure time train click spring. The attachment point for the click spring on the time train barrel had no positive securing point, (Figure 10). Unlike that on the strike barrel, which was secured by a square stud (Figure 11) the time barrel spring was held in place only by the friction of the bolt holding it to the drum's main wheel. Should this spring ever come out of position, a catastrophic runaway would occur. The obvious solution would be to have a locating pin installed. Since we did not want to alter the original artifact we used Loctite on this point.

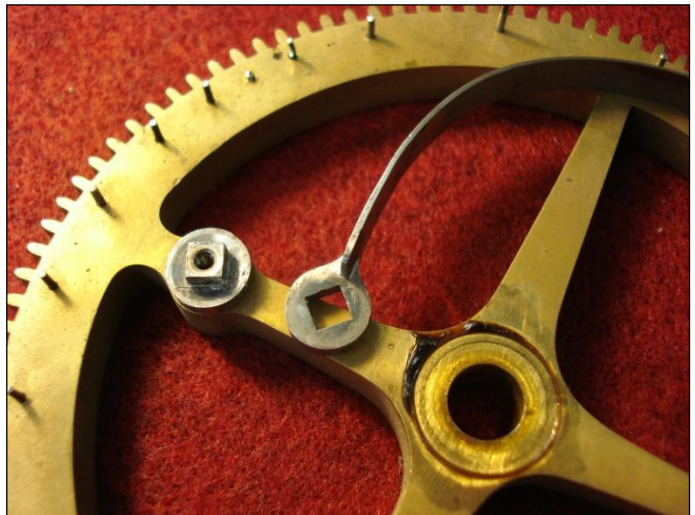
Figure 11. Properly secured strike train click spring.

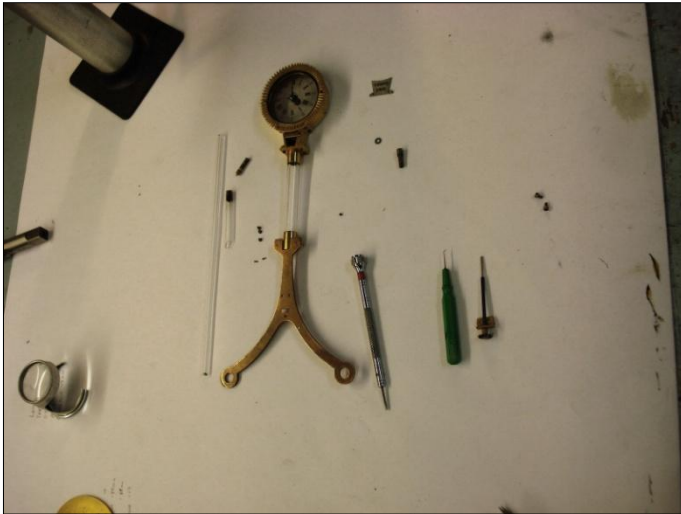
The dial was supported by a glass tube, which was intact, but an inner glass tube which drove the glass dial was shattered with most of that tube missing. Figure 12 shows the parts as found. Next the replacement tube is fabricated and shown next to the old, damaged tube, (Figure 13). The new glass tube was fitted to replace the one that was broken to bring back the mechanical connection to the dial. Figure 14 shows the completed assembly with Figure 15 showing the retouched glass mystery dial.

Figure 12. Mystery dial assembly as found

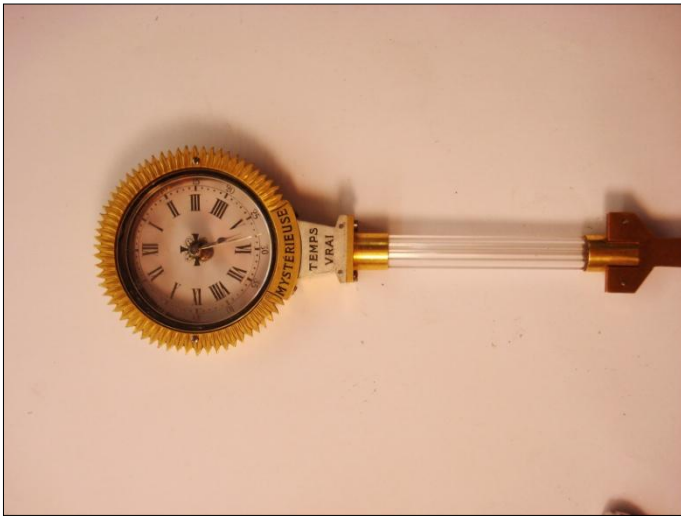
Figure 14. Completed mystery dial assembly

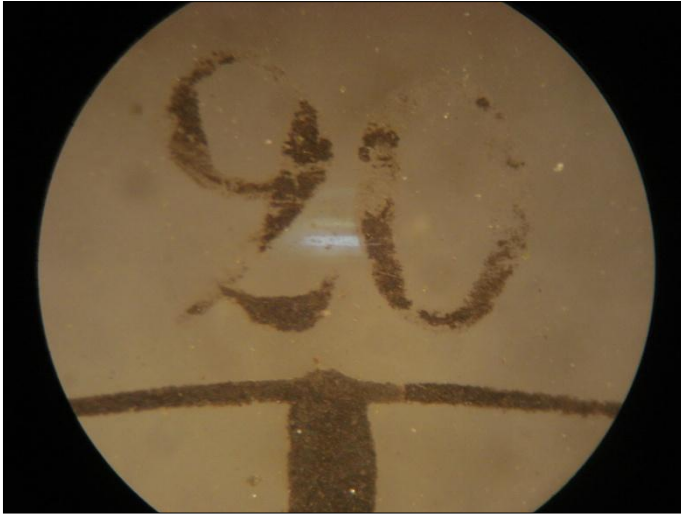
Figure 16. Numeral as found

Figure 18. Numeral as found

Some of the painted numbers on the dial face were partially rubbed off making parts of the dial illegible, (Figures 16, 18) and those missing areas were carefully retouched on the glass to fill in the missing sections only. The view shown is at 20x magnification, (Figures 17, 19) resulting in the legible dial shown in figure 15.

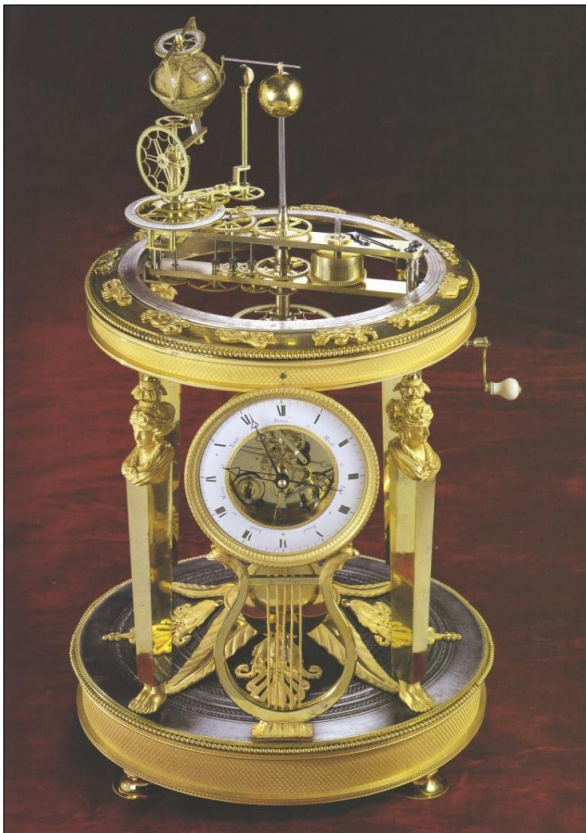
Figure 22. Tellurian by Zacharie Raingo, c. 1790

Pouvillon did not think up the spoke design on his own. He drew his inspiration from a tellurian by Zacharie Raingo, c. 1790, to create his step wheel for the annual cam pack, (Figures 22, 23).

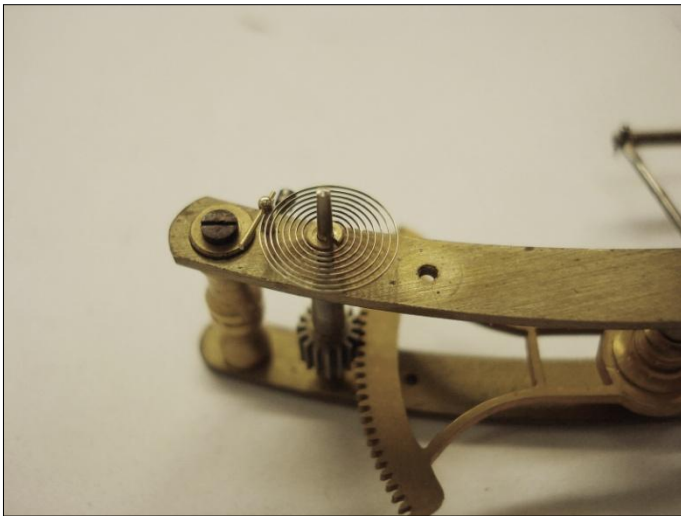
Figure 39. Spiral bias spring fitted to extant arbor

7. Restore sunrise/sunset dial spiral bias springs, replace missing hand. The two dials indicating the times of sunrise and sunset mentioned in part five of this chapter was each missing their spiral bias springs. These looked similar to what the balance wheel hairspring would look like in a large pocket watch. They are needed to hold the dial hands in place to counter any inaccuracies due to lash between the dial pinion hand and its driving sector gear. Again, given the parameters of the needed function and the existing mounting points we are quite sure that a spiral is the type of spring originally used in this application. Indeed this type of spring fits perfectly on the dial hand arbor with the end of the spring being neatly pinned within an existing hole in a nearby pillar, (Figure 39, 40).

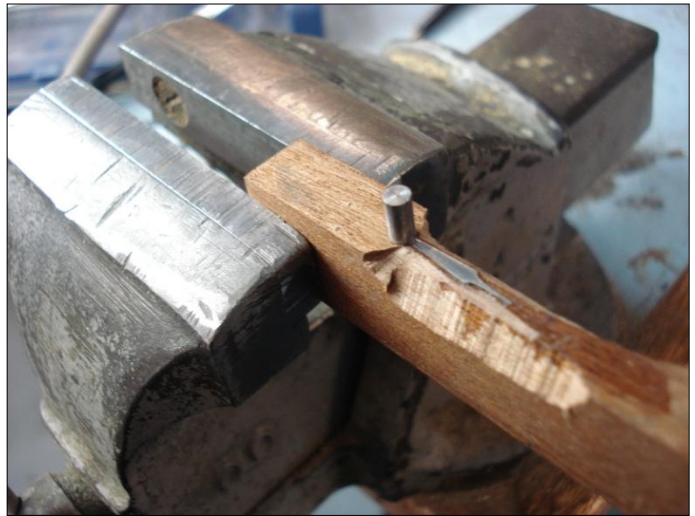
Figure 42. Replacement being hand filed to shape

One dial hand was also missing and a new one was made to match the existing one. Figure 41 shows a section of main spring steel used as blank material for this purpose. Figure 42 shows the traditional filing method used to fabricate the hand. On the next page is the completed hand, left, next to its mating original. Next is its installation along with the spiral bias springs within the sunrise/sunset dial network (Figures 43, 44).

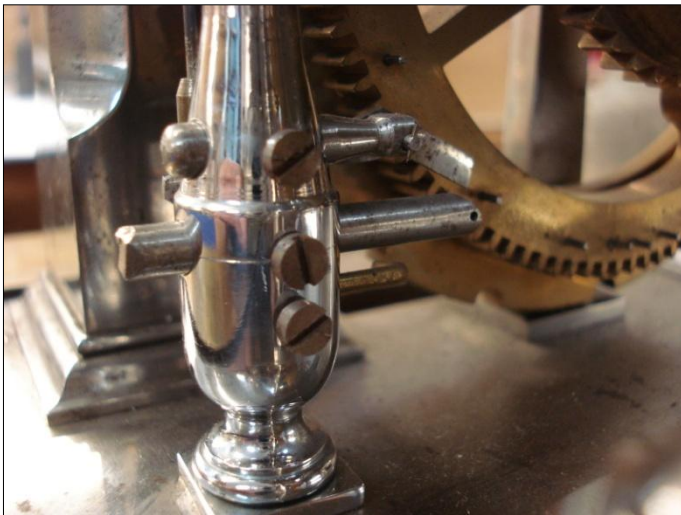
A. Restore calculator's automatic annual trip linkage from cam pack to calculator. Sometime in the past a previous repairer had tried to figure out how to trip the Easter calculator. This had probably occurred after the annual cam pack, described previously, went missing. Without this part the calculator could not function as intended. Someone had installed a lever that was tripped by a pin driven into the face of the strike train main wheel and linked this to the Epact ratchet wheel trip lever within the calculator directly above. This pin was of a different material and longer than the prior pins which were used in the clock as a count wheel, (Figure 49). The pin used to trip this lever is clearly something that was added to the strike wheel at a later

date and would have tripped the Epact dial once every day, the same period as the strike train wheel rotates. This makes no sense since the Epact is a once per year indication. It is the age of the moon on January 1st and so the dial is demarked from 1 through 30. Simply feeding the Epact dial once per day would not have activated the rest of the calculator in any event. Furthermore, the lever and its clevis looked to be something factory-made and what one would have seen in a contemporary radio controlled model, and not from the time or in the manner Pouvillon would have made these parts, (Figures 50, 51). Therefore this linkage was removed. One may inquire why such an attachment point on the Epact ratchet was available if it were not meant to have some type of lever attached to it, (Figure 52). We will answer this in section C.

Figure 49. Epact trip lever driven off strike train wheel

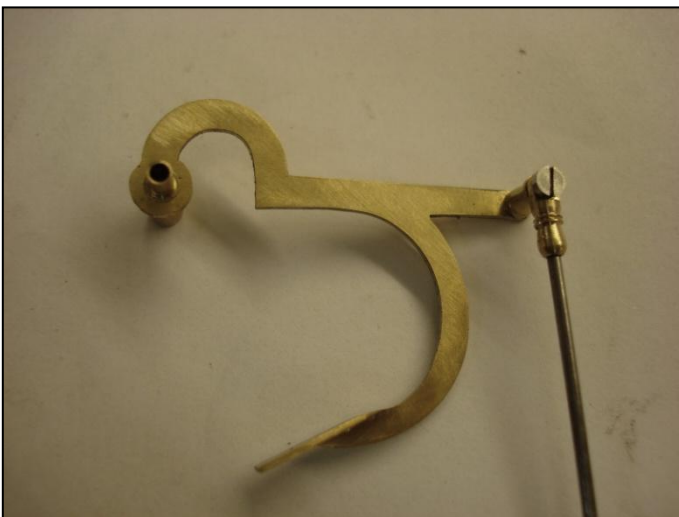
Figure 55. Trip lever which operates off the snail cam

First we restore a lever linkage connected to the fifth cam, the snail trip cam. Riding on this cam is a lever which will be tripped once per year. We cannot know exactly how Pouvillon would have made this lever appear absent original photographs but we are confident that the Easter calculator would have been actuated from this location given the existing lever pivot mounting points on the extant drop down bracket, the space on the annular cam pack for the trip snail and the fact it is in the correct alignment from this cam to the Easter calculator's trip lever location directly below, (Figures 55, 56). We studied the adjacent lever Pouvillon made for the equation of time function and made this lever and clevis in the same style and damascene finish, (Figures 57, 58).

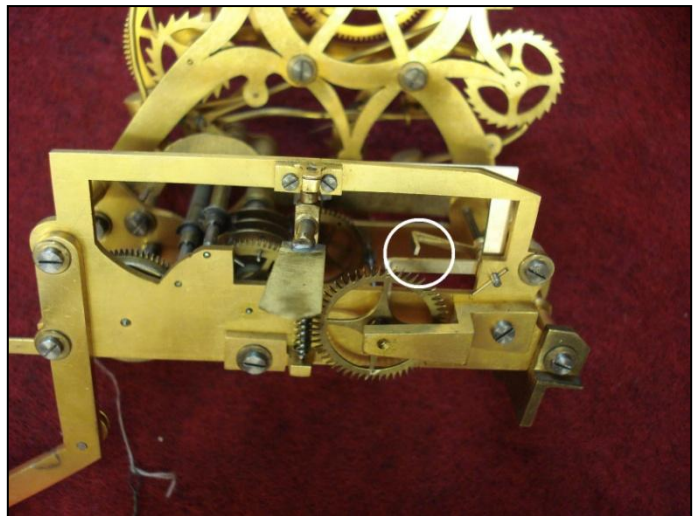
Figure 60. Restored warning lever

We had ample evidence that such levers existed not only from the fact that they necessary for the calculator to work, but also witness marks on the arbor which indicated that parts were mounted to an area where the bluing was missing. The position of the drive wheel's detent pin dictates how long the warning lever must be, (Figure 61). The area where the witness marks showed prior mounting points were neatly filled with the collets for the restored warning and trip levers, (Figure 62).

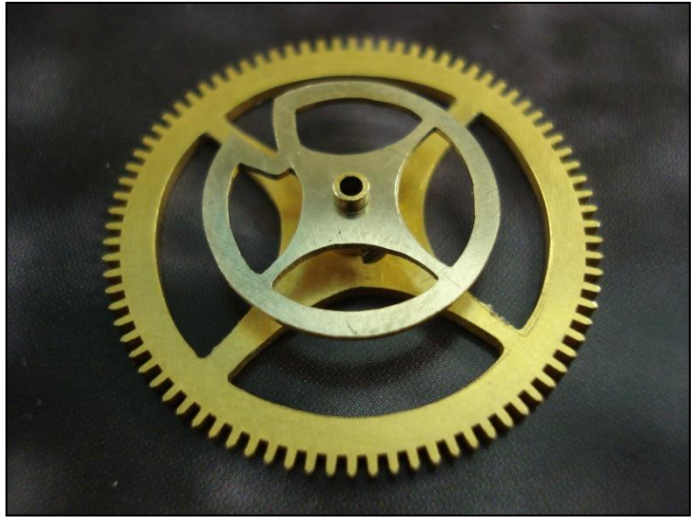
Figure 64. Epact 19 year correction cam.

There is another dial on the calculator called the Golden Number which indicates the number of the year in the lunar cycle and conveniently, it has 19 divisions and it rotates once in 19 years. In addition, a careful review of the dial output arbor in this part of the calculator reveals an unused shoulder on the drive wheel where it appears there was a mounting point for another component, (Figure 63). We restored what we believe was Pouvillon's solution to the perpetual epact by designing a cam fitted and mounted to this location, (Figure 64).

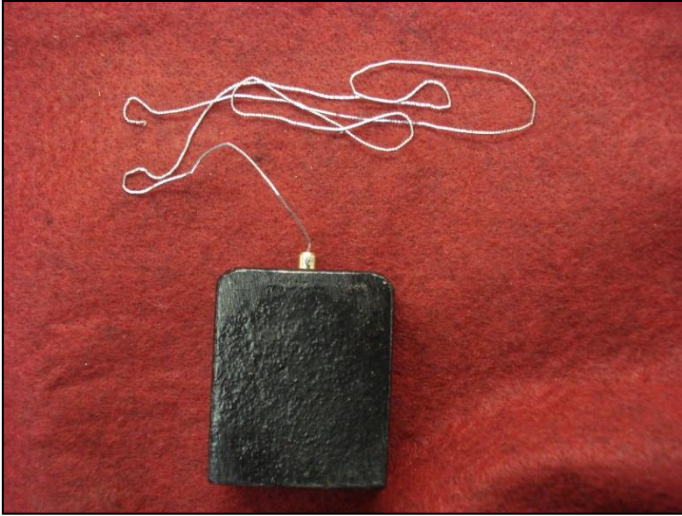
Figure 69. Weight and chain for the Easter calculator

D. Replace missing calculator drive chain and weight. This was a minor restoration. The calculator uses a small, separate weight driven power source apart from that of the clock itself. It was obvious the auxiliary weight present was a later addition as it was simple piece of scrap metal. The weight line was missing. A careful examination of the winding drum and pulley system for the calculator revealed that these had a flat-bottomed profile with even-spaced ‘nicking’ on the surface indicating that a chain similar to that of a watch fusee chain was used. Furthermore, there is an attachment point identical to what one would find on a fusee barrel to receive a chain hook. We remade the weight and created an extra long chain needed for this application from several old watch fusee chains, (Figure 69). Figure 70 shows the pulley guides that direct the chain from the winding barrel to a hole in the base of the clock platform. The Easter calculator weight hangs in the wood base along with the other weights.

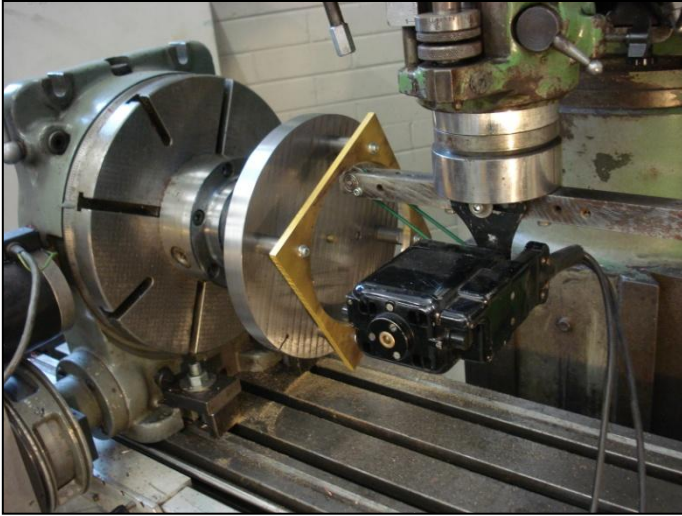
Figure 77. Cutting the 450 internal teeth on a 5" ring.

We begin with the gear that will drive the lower zodiac band. This consists of a thin ring gear with a diameter of five inches and an internal tooth count of 450. We made two of these; the second to be used in the next complication. Figure 77, shows the internal teeth being cut. Figure 78 shows the rough wheels mounted to the as yet, unfretted frame.

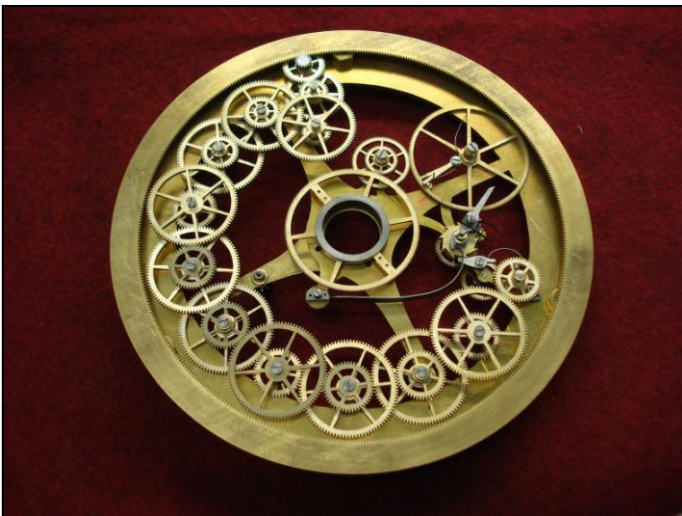
Figure 79. Cut out frame sandwiched onto original frame

In figure 79 the wheel works are finished off as well as the frame cut out to mirror exactly the existing tellurian base frame and are sandwiched to that frame, (Figure 80). It is held to the original frame using the existing empty holes in the frame.

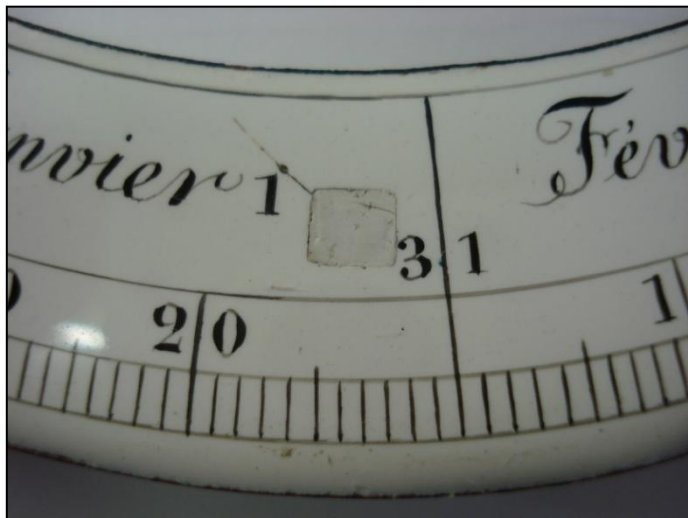
Figure 82. Filled in square aperture from the front.

As received the aperture on the dial was closed with a white filler material, (Figures 82, 83). Here we begin to get into some pure speculation. On the one hand Pouvillon was anxious to have as many complications as could pack into his clock. Moreover, this indication was not repeated anywhere else within the movement and if Pouvillon received the tellurian structure intact, it should have had this complication already present and ready to go. He would have had every incentive to use it. On the other hand, what if the tellurian was not complete and we presume that the year date ring and maybe the associated driver were missing? In this case Pouvillon may have taken the easy way out and simply dispensed with the effort to recreate this complication

To be honest, if we had not decided to restore the zodiac precession I would have assumed Pouvillon had taken the second course and left the aperture covered. But, since I was confident that Pouvillon did make the zodiac precession and we had now restored the drive to the zodiac precession ring it was a straight forward job to extend this drive to the annual date ring as well, see schematic page 76. Both rings employed the same internal 450 tooth counts. It also returned what is a fairly important piece of information not duplicated elsewhere within the overall context of the clock and removed what seemed to be evidence either of a shortcut or effort to conceal the loss of parts.

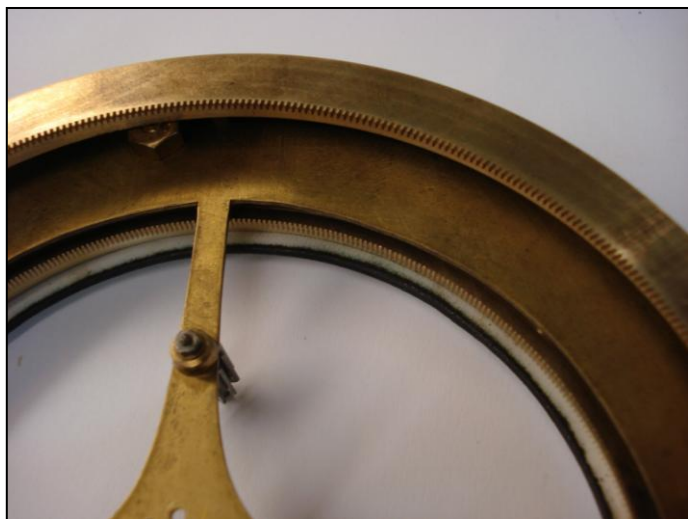
Figure 84. The 450 internal toothed ring gear for the years

and covered up the aperture. We do know after the fact that creating this ring took quite a bit of time and skill; surely Pouvillon had the skills but we do not know if he actually did it, (Figure 84). Of course a third alternative could be that this complication was lost as were many other parts during events after Mr. Pouvillon's passing and the aperture then closed up. Unfortunately we have no historical photographs that show this area with enough clarity for us to make the proper determination.

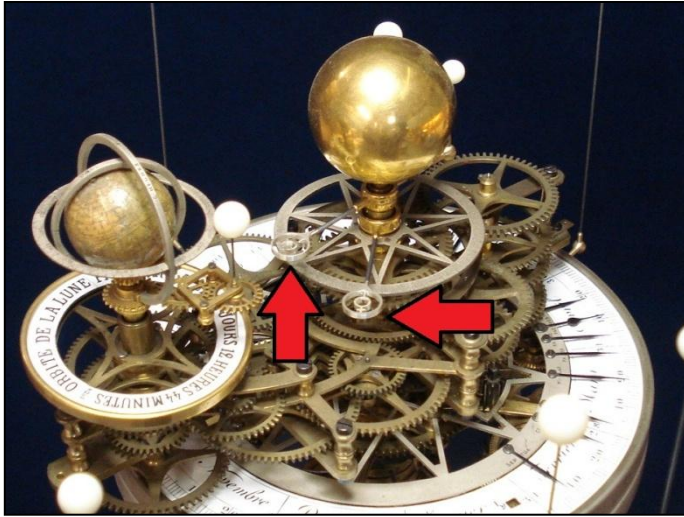
Figure 88. Graduated ring with inner planet zodiac signs

may have a clue. There is a small ring graduated into 360^0 that is positioned beneath the two inner planets, (Figure 88). And the fixed silver upper band surrounding the tellurian and positioned above the zodiac ring is also demarked in the same way, (Figure 91, page 49). Could we somehow use the empty attachment points along with these similarly graduated indicators?

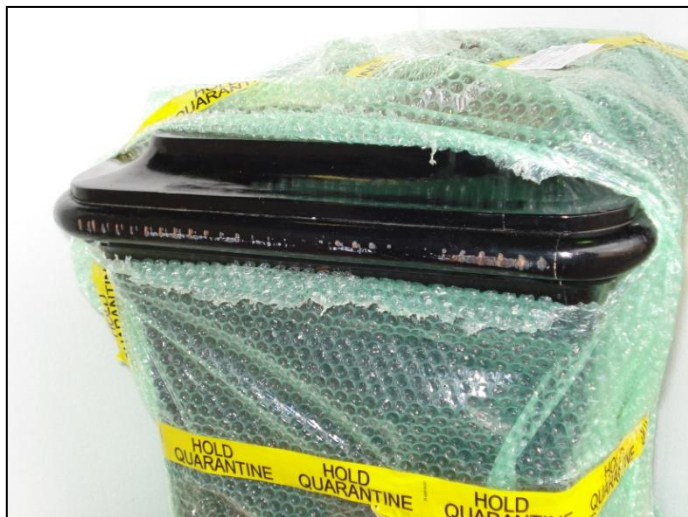
Figure 1. Base held for quarantine by Australian Customs

When the wood base was examined by Australian Customs it was found to have had an old infestation of wood worms. Even so, the Customs officials insisted that the base go through quarantine and be fumigated to eliminate any danger of infestation. The clock and base had been well packed in England and had made the journey to Australia without incident. However, the fumigators had damaged the base. It looks like something had either backed into it or ran across it, (Figures 1, 2). This is the nightmare of anyone who ships valuable clocks – damage in transport. Thankfully the clock was not attached to the base at the time and made it through intact. In addition to the scarring along the upper edge, the base was slightly smashed, probably from impact with a forklift truck. Here we have a close up of the lower section damages, Figures 3, 4)

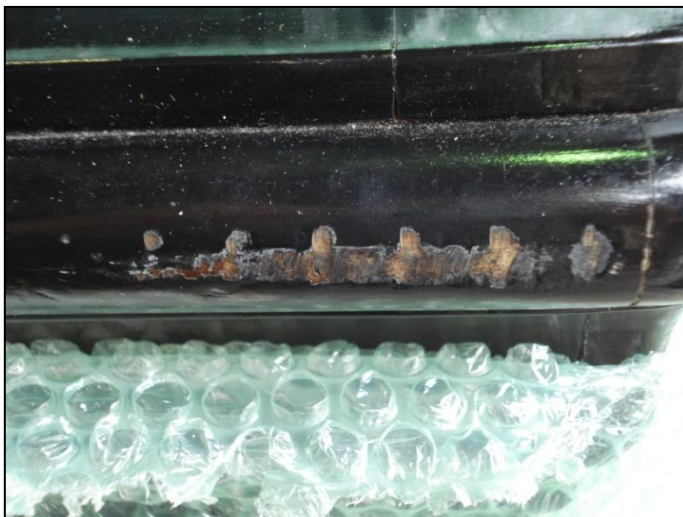
Figure 2. Close up of damages caused by fumigators

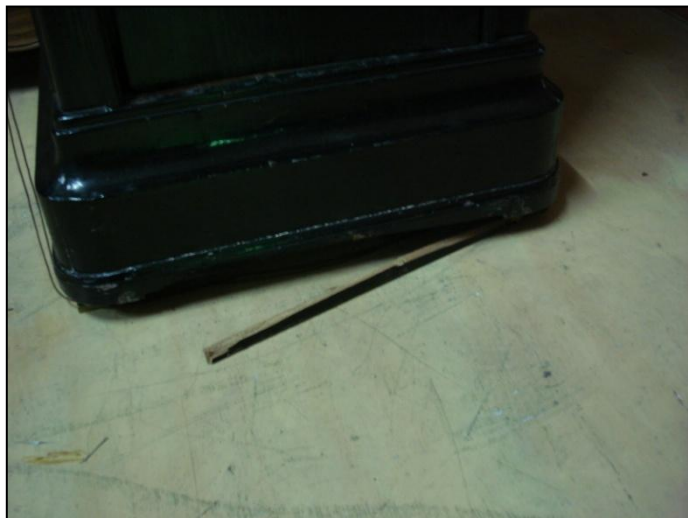
Figure 3. Further damage to the lower edge of the base

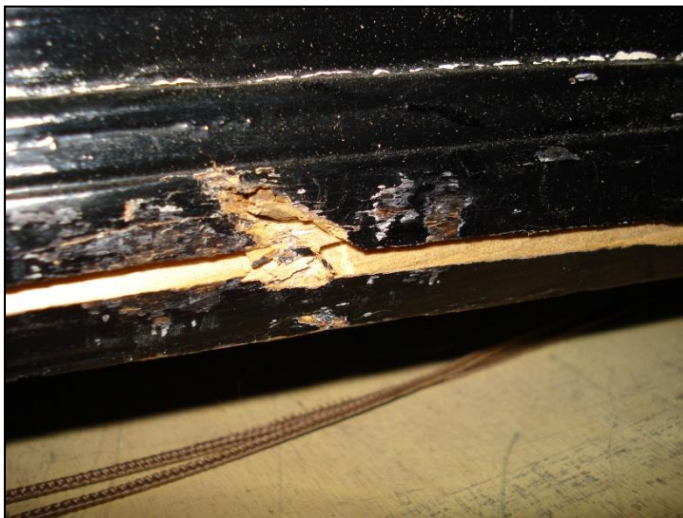
Figure 4. Close up of impact damage to lower edge.

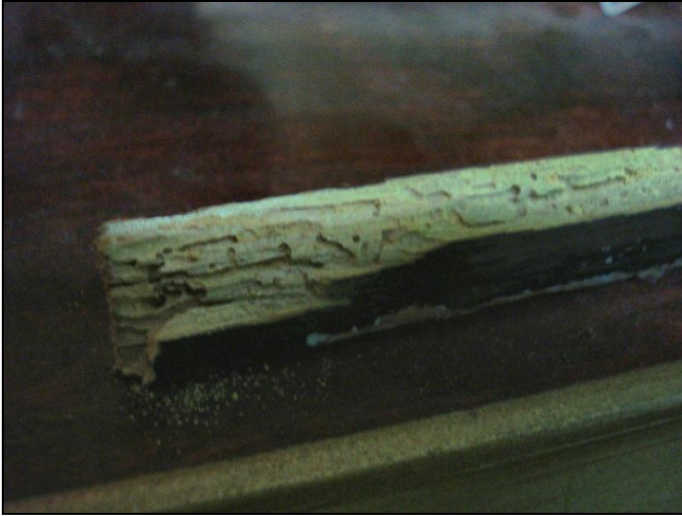
Figure 5. Extensive wood worm damage, starting to crumble

Figure 5 shows a section of wood that had come away with extensive wood worm damage. Notice the wood powdering near the lower end; the structure is beginning to crumble. Figure 6 shows another section with similar damage. At this point we were unsure if the case had retained enough structural integrity to support the heavy weights that powered the clock.

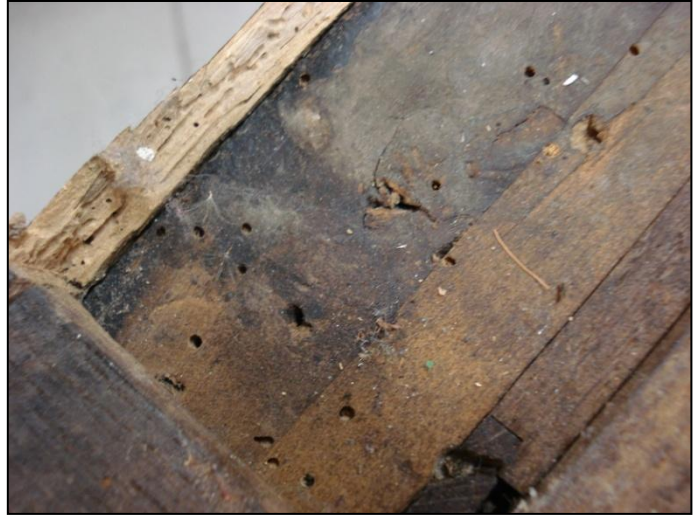
Figure 6. Further damaged areas

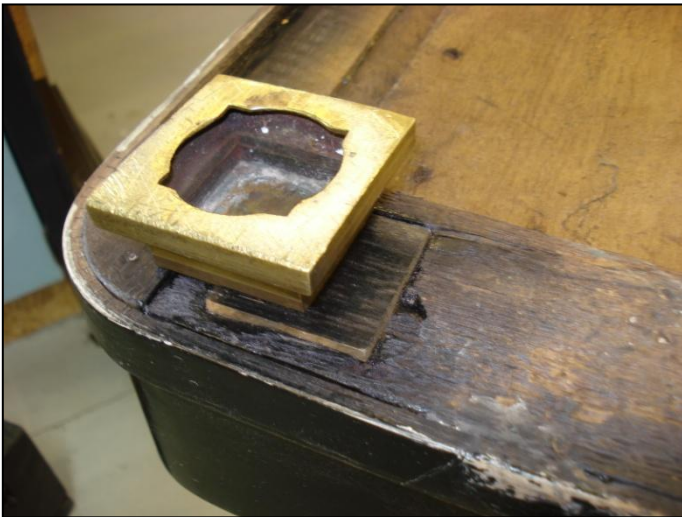
Figure 7. Wood insert below where brass foot is attached

Figures 7 and 8 show two areas of the underside where the brass feet are secured. In the first photo one can see the area adjacent to the removed brass foot that has been filled in with a later wood section. Most likely the wood insert was necessary after that area had suffered numerous changes resulting in too many holes, weakening that area. The next photo depicts another mounting point with evidence that the foot has been moved at least once or that an alternative foot with another set of holes was used before the current version.

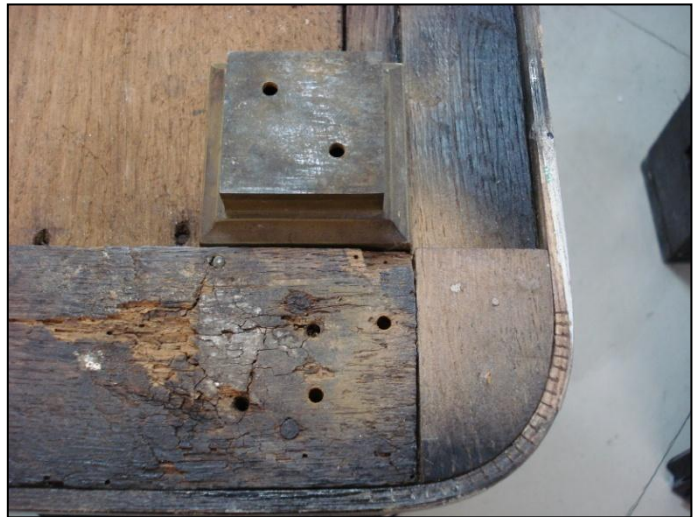
Figure 8. Evidence of foot repositioned or replaced

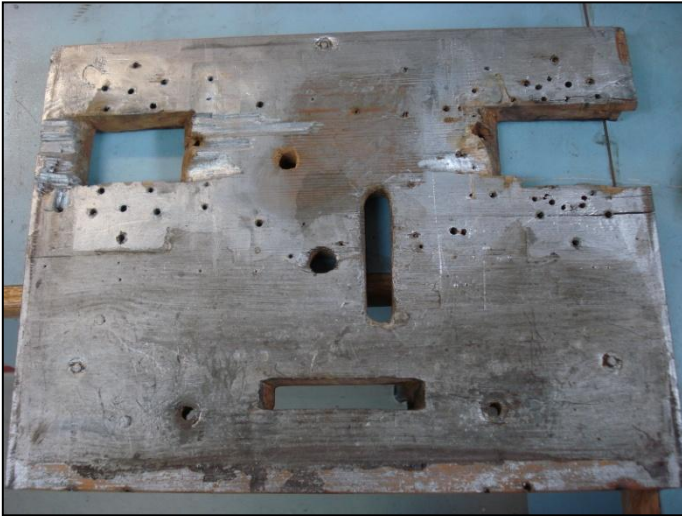
In figure 9 we show the lower seat board for the clock. One can see the numerous holes indicating the various changes in either position or hardware that was attached to this piece. This lower seat board has the upper weight pulley set attached. There are two seat boards, sandwiched one upon the other. The upper board is

Figure 9. Lower seat board

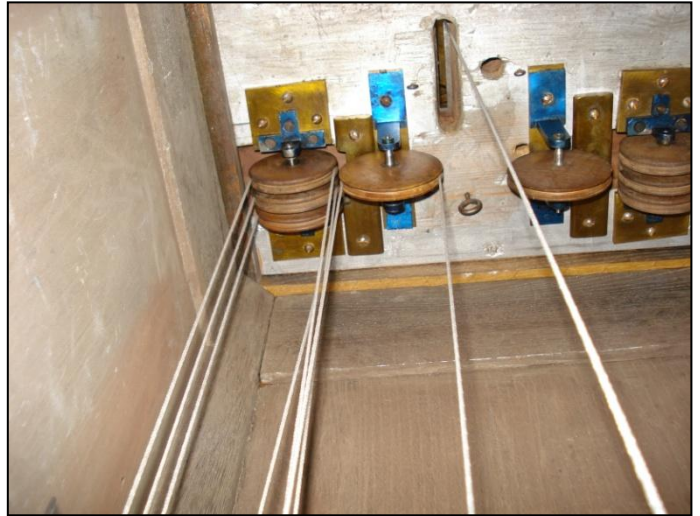
Figure. 10. Lower seat board with pulley sets attached

The weights are triple compounded and so are quite heavy requiring the case to have a good structural integrity. The rigging from above is shown, (Figure 10) as well as one of the weights from below, (Figure 11). After an initial trial it appears that the seat board is sufficiently strong to take the weights

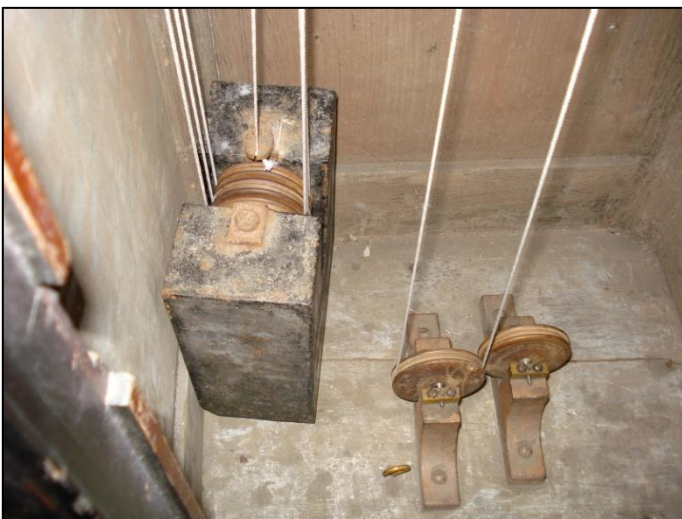
Figure 11. View of pedestal floor

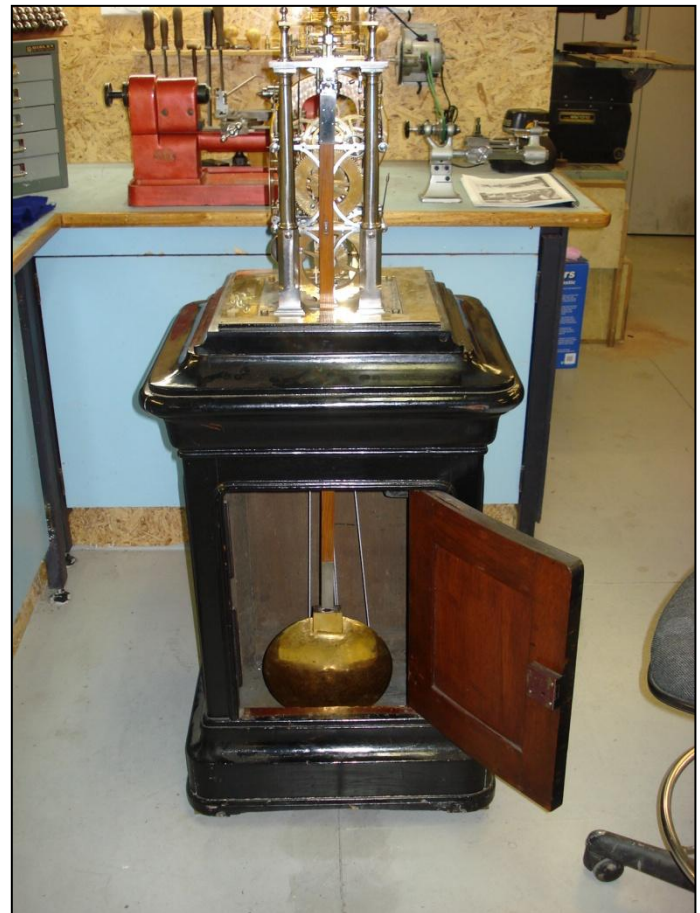
Figure 12. Initial structural integrity test, rigging up weights

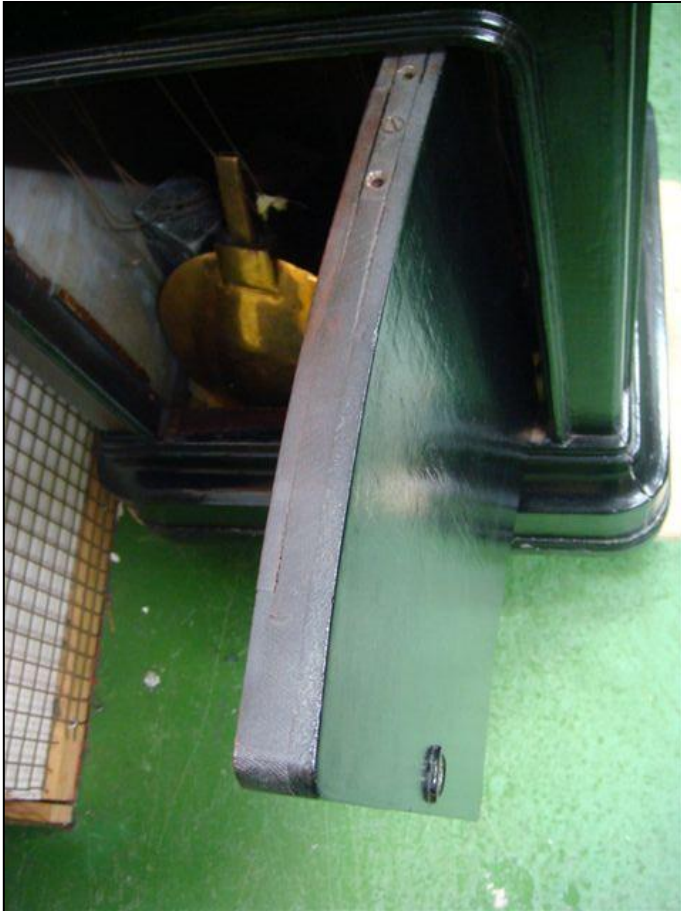
Figure 13. Base access door showing sever warping

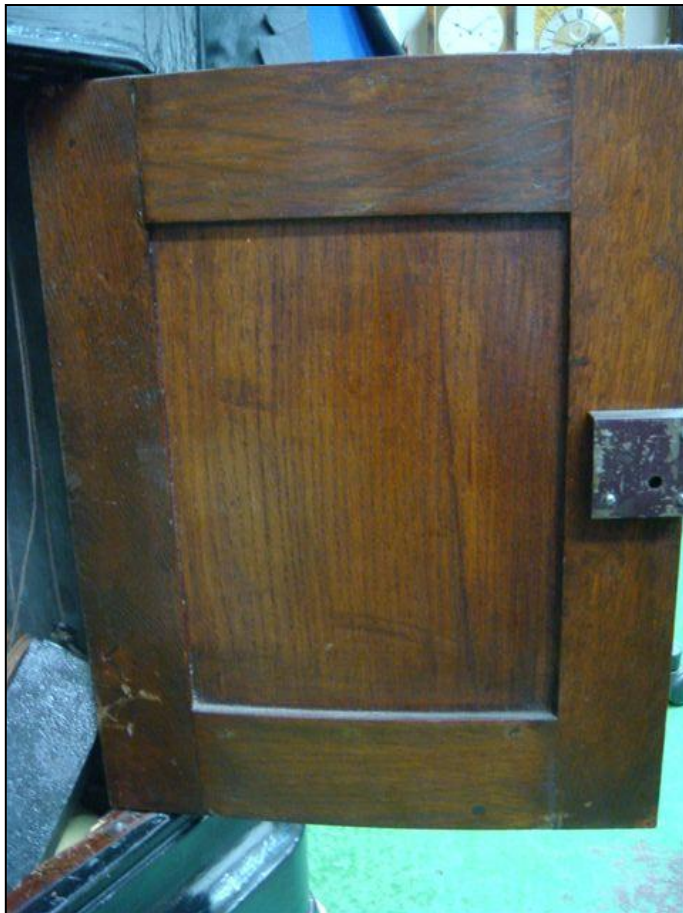
Figure 15. An indication of the original finish on inside

Figure 15 shows evidence that the wood base did not originally have a black, painted finish. In fact, upon close inspection the black finish was a spray painted coating on the underlying wood finish. The spray painted finish seemed to be fairly easy to scrape off without causing too much damage to the underlying surface, (Figure 16).
